Human Blood in the Water System

Public Health Significance of Cross-Connections

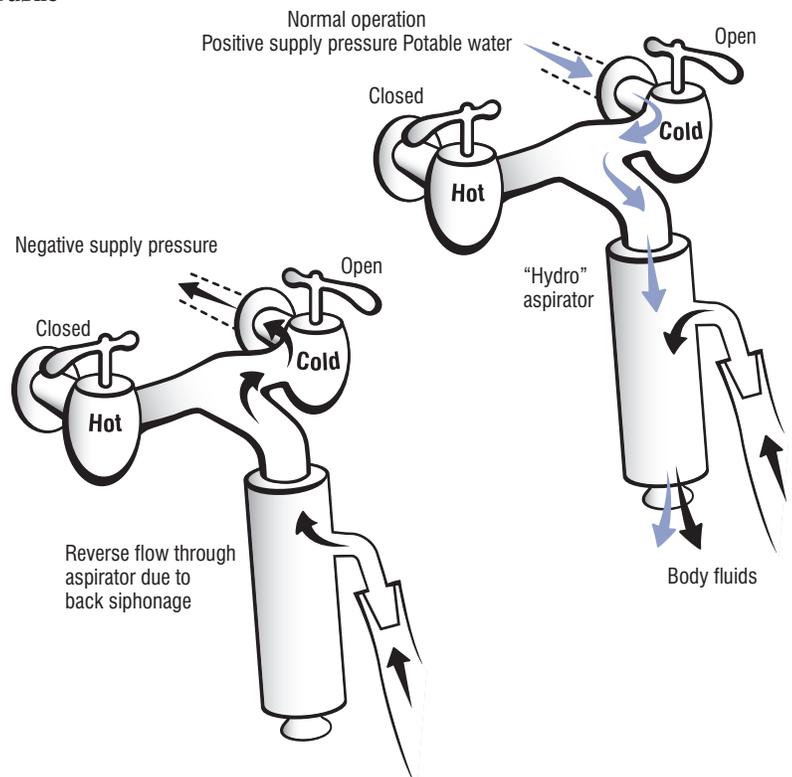
Investigation revealed that the funeral home had been using a hydraulic aspirator to drain fluids from the bodies of human “remains” as part of the embalming process. The aspirator directly connected to the water supply system at a faucet outlet located on a sink in the “preparation” (embalming) room. Water flow through the aspirator created suction that was utilized to draw body fluids through a hose and needle attached to the suction side of the aspirator.

The contamination of the funeral home potable water supply was caused by a combination of low water pressure in conjunction with the simultaneous use of the aspirator. Instead of the body fluids flowing into the sanitary drain, they were drawn in the opposite direction—into the potable water supply of the funeral home!

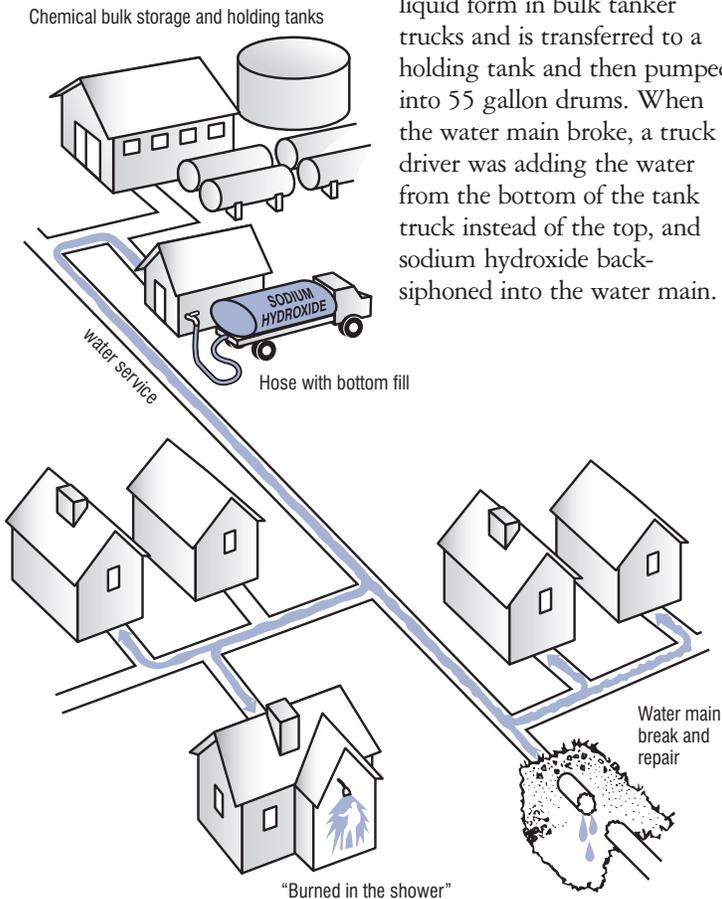
The incident began after an 8-inch water main, that fed the town, broke and was repaired. While repairing the water main, one workman suffered leg burns from a chemical in the water and required medical treatment. Measurements of the pH of the water were as high as 13 in some sections of the pipe.

Investigation into the cause of the problem led to a possible source of the contamination from a nearby chemical company that distributes chemicals such as sodium hydroxide. The sodium hydroxide is brought to the plant in liquid form in bulk tanker trucks and is transferred to a holding tank and then pumped into 55 gallon drums. When the water main broke, a truck driver was adding the water from the bottom of the tank truck instead of the top, and sodium hydroxide back-siphoned into the water main.

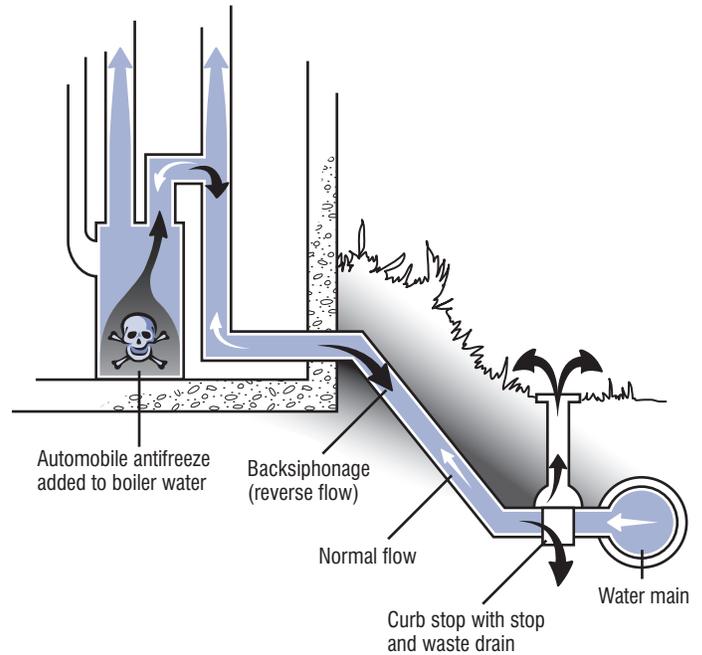
Bangor Maine Water Department employees discovered poisonous antifreeze in a homeowner's heating system and water supply in November, 1981. The incident occurred when they shut off 'the service line to the home to make repairs. With the flow of water to the house cut off, pressure in the lines in the house dropped and the anti-freeze, placed in the heating system to prevent freeze-up of an unused hot water heating system, drained out of the heating system into house water lines, and flowed out to the street. If it had not been noticed, it would have entered the homeowner's drinking water when the water pressure was restored.

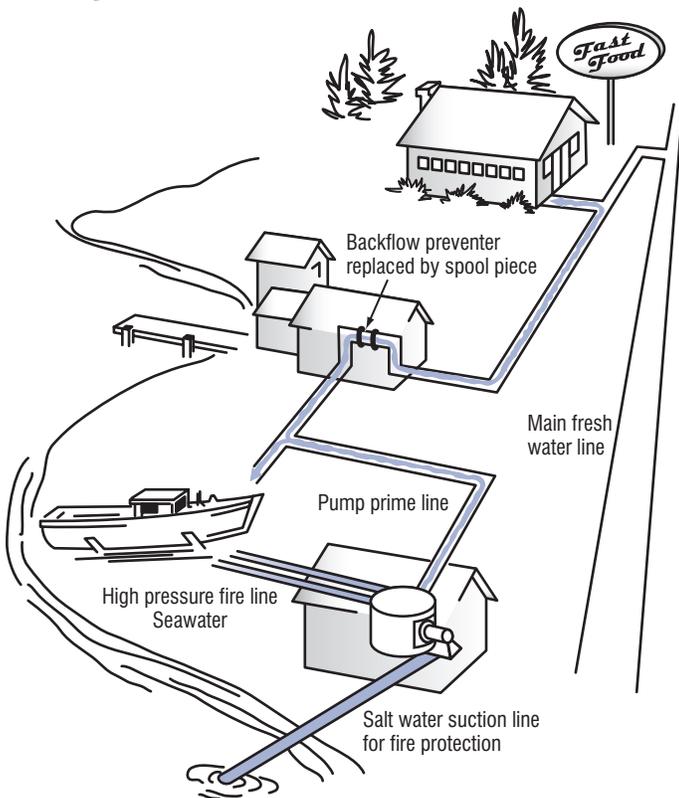
- A backflow preventer that had been installed on the service line to the shipyard had frozen and had been replaced with a spool piece sleeve.
- The shipyard fire protection system utilized sea water that was pumped by both electric and diesel driven pumps.
- The pumps were primed by potable city water.

With the potable priming line left open and the pumps maintaining pressure in the fire lines, raw salt water was pumped through the priming lines, through the spool sleeve piece, to the ship repair facility and the restaurant.

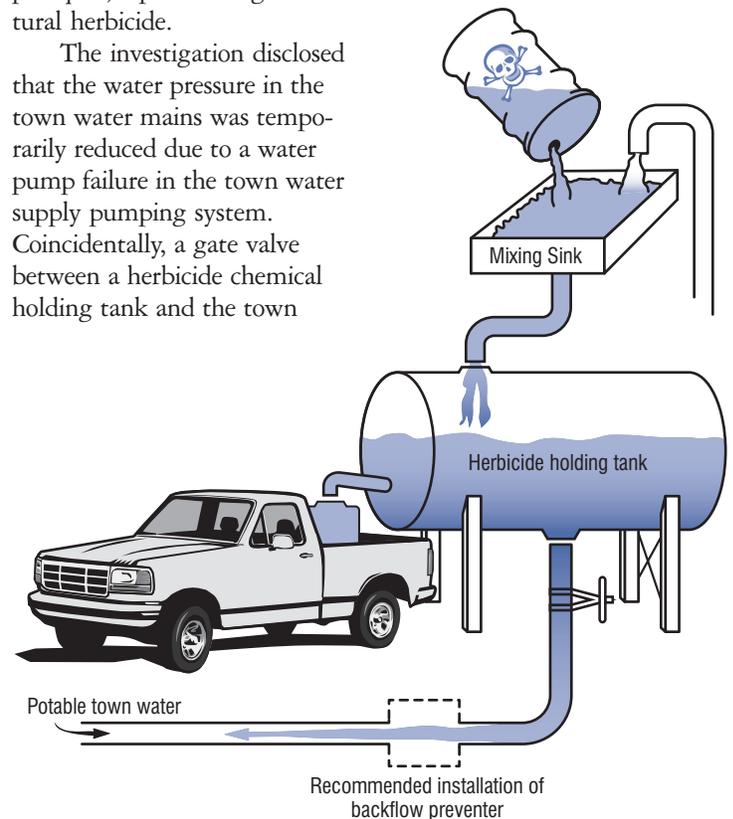
The investigation disclosed that the water pressure in the town water mains was temporarily reduced due to a water pump failure in the town water supply pumping system. Coincidentally, a gate valve between a herbicide chemical holding tank and the town

water supply piping had been left open. A lethal cross-connection had been created that permitted the herbicide to flow into the potable water supply system. Upon restoration of water pressure, the herbicides flowed into the many faucets and outlets on the town water distribution system.

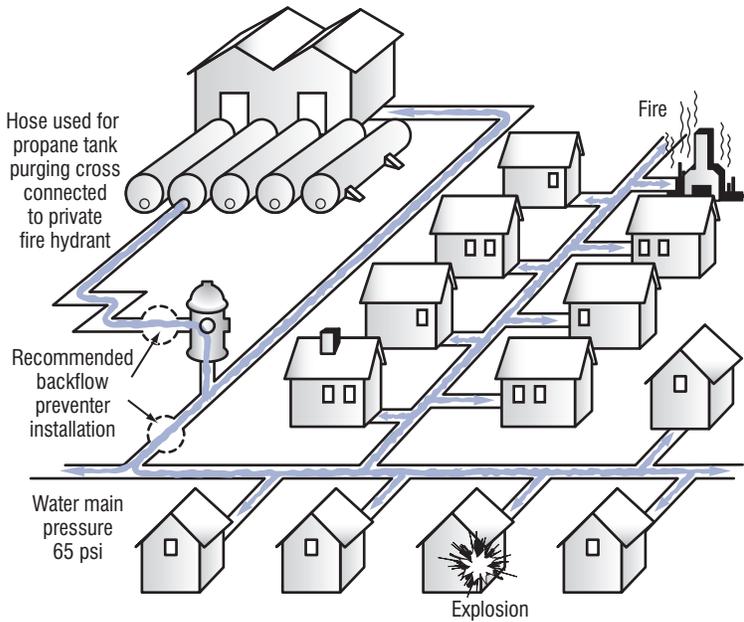
ate repair procedures. To start the repair, the tank was “purged” of residual propane by using water from one of two private fire hydrants located on the property. Water purging is the preferred method of purging over the use of carbon dioxide since it is more positive and will float out any sludge as well as any gas vapors. The “purging” consisted of hooking up a hose to one of the private fire hydrants located on the property and initiating flushing procedures.

Since the vapor pressure of the propane residual in the tank was 85 to 90 psi., and the water pressure was only 65 to 70 psi., propane gas backpressure backflowed into the water main. It was estimated that the gas flowed into the water mains for about 20 minutes and that about 2,000 cubic feet of gas was involved. This was approximately enough gas to fill one mile of an 8-inch water main.

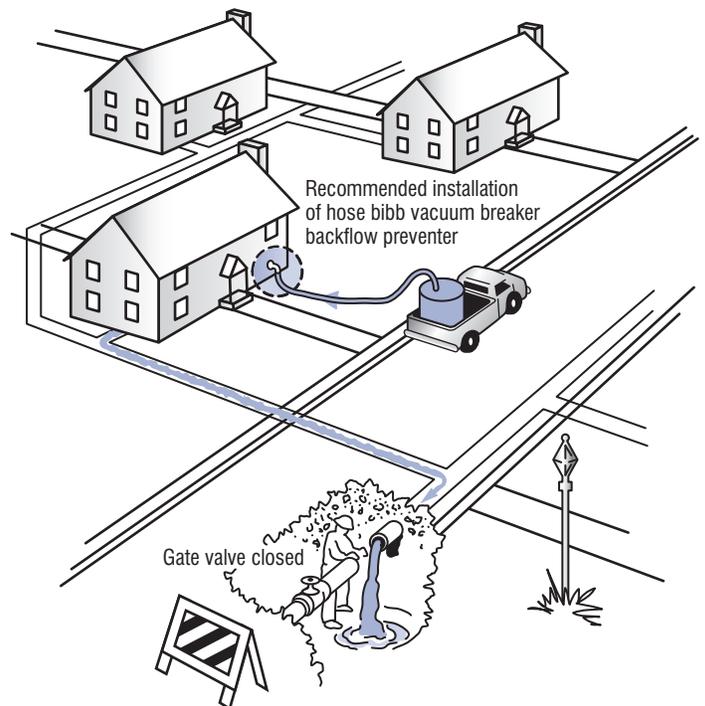
The services to seventy five apartments housing approximately three hundred people were contaminated with chlordane and heptachlor in a city in Pennsylvania, in December, 1980. The insecticides entered the water supply system while an exterminating company was applying them as a preventative measure against termites. While the pesticide contractor was mixing the chemicals in a tank truck with water from a garden hose coming from one of the apartments, a workman was cutting into a 6-inch main line to install a gate valve. The end of the garden hose was submerged in the tank containing the pesticides, and at the same time, the water to the area was shut off and the lines being drained prior to the installation

of the gate valve. When the workman cut the 6-inch line, water started to drain out of the cut, thereby setting up a backsiphonage condition. As a result, the chemicals were siphoned out of the truck, through the garden hose, and into the system, contaminating the seventy five apartments.

Repeated efforts to clean and flush the lines were not satisfactory and it was finally decided to replace the water line and all the plumbing that was affected. There were no reports of illness, but residents of the housing authority were told not to use any tap water for any purpose and they were given water that was trucked into the area by volunteer fire department personnel. They were without their normal water supply for 27 days.

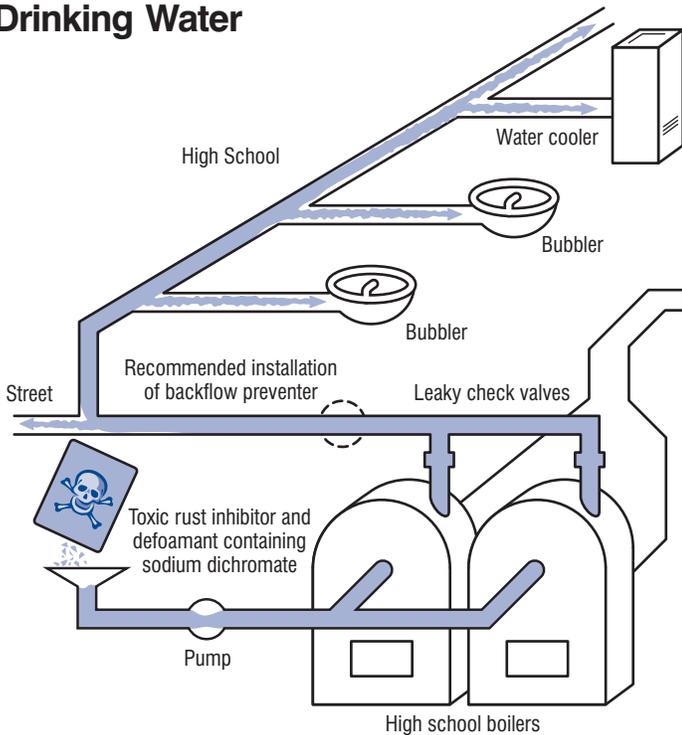
A high school in New Mexico, was closed for several days in June 1984 when a home economics teacher noticed the water in the potable system was yellow. City chemists determined that samples taken contained levels of chromium as high as 700 parts per million, “astronomically higher than the accepted levels of .05 parts per million.” The head chemist said that it was miraculous that no one was seriously injured or killed by the high levels of chromium. The chemical was identified as sodium dichromate, a toxic form of chromium used in heating system boilers to inhibit corrosion of the metal parts.

Investigation disclosed that chromium used in the heating system boilers to inhibit corrosion of metal parts entered the potable water supply system as a result of backflow through leaking check valves on the boiler feed lines.

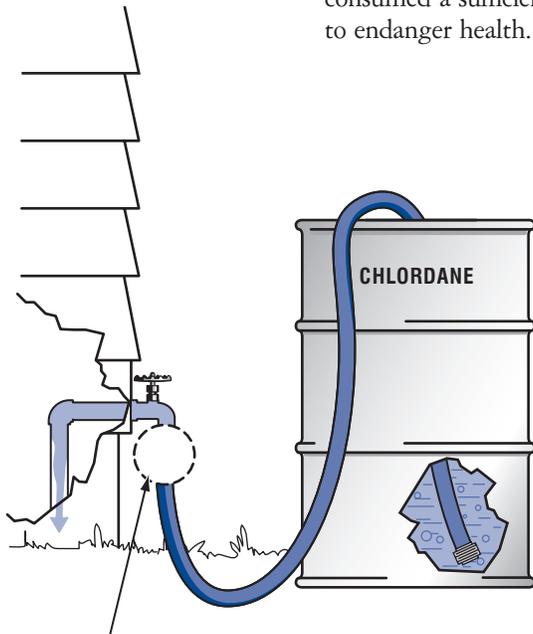
The problem developed while water department personnel were repairing a water main. A professional exterminator, meanwhile, was treating a nearby home with chlordane for termite elimination. The workman for the exterminator company left one

end of a garden hose that was connected to an outside hose bibb tap in a barrel of diluted pesticide. During the water service interruption, the chlordane solution was back-siphoned from the barrel through the house and into the water mains.

Recommended installation of hose bibb vacuum breaker backflow preventer

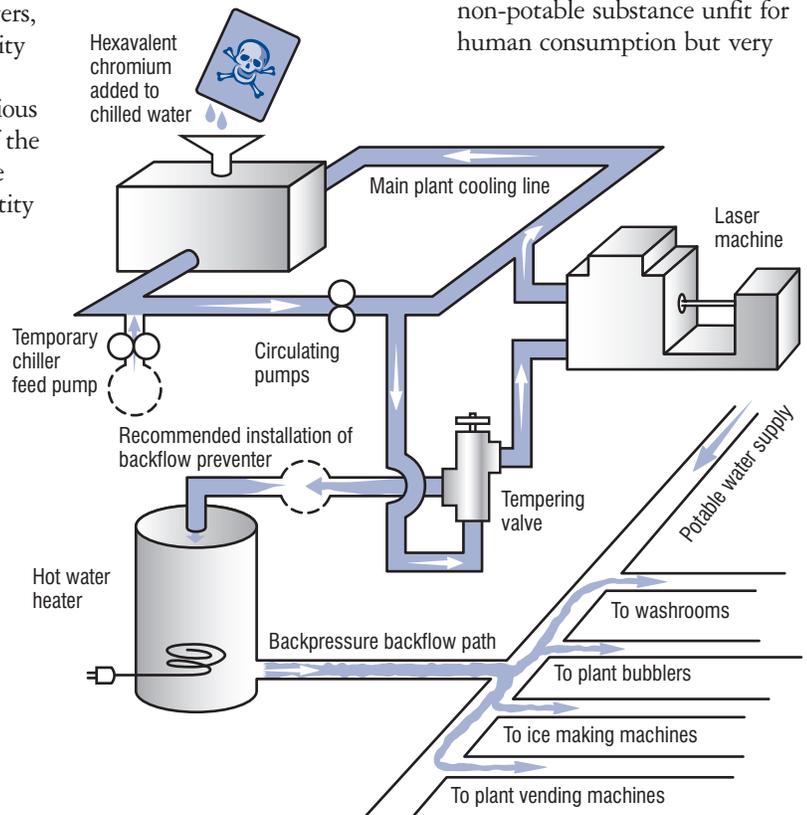
- Laser machine lenses were kept cool by circulating chilled water that came from a large refrigeration chiller. The water used in the chiller was treated with hexavalent chromium, a chemical additive used as an anticorrosive agent and an algicide. As a result, the chilled water presented a toxic, non-potable substance unfit for human consumption but very

- A maintenance mechanic correctly reasoned that by adding a tempering valve to the chilled water line, he could heat up the water a bit and eliminate fogging of the laser lenses resulting from the chilled water being too cold. The problem with the installation of the tempering valve was that a direct cross-connection had been inadvertently made between the toxic chilled water and the potable drinking water line!

- Periodic maintenance to the chiller system was performed in the summer, requiring that an alternate chiller feed pump be temporarily installed. This replacement pump had an outlet pressure of 150 psi, and promptly established an imbalance of pressure at the tempering valve, thereby over-pressurizing the 60 psi, potable supply. Backpressure backflow resulted and pushed the toxic chilled water from the water heater and then into the plant's potable drinking water supply. Yellowish green water started pouring out of the drinking fountains, the washroom, and all potable outlets.

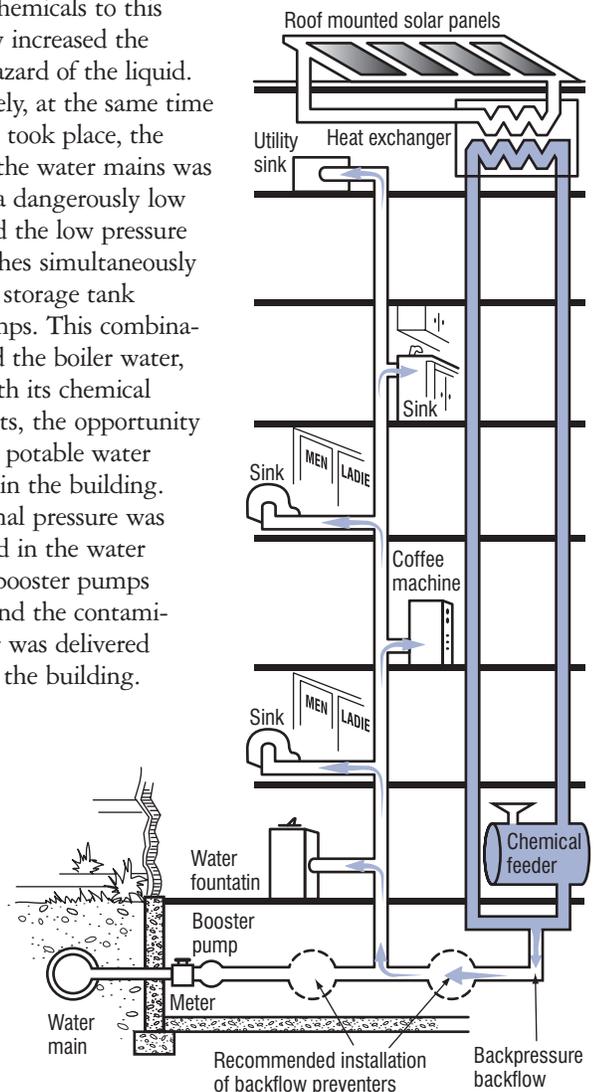
Water pH levels of the building water indicated that an injection of chemicals had probably taken place within the seven-story building. Tracing of the water lines within the building pinpointed a 10,000 gallon hot-water storage tank that was used for heat storage in the solar heating system. It did not have any backflow protection on the make-up

supply line! As the storage tank pressure increased above the supply pressure, as a result of thermal expansion, the potential for backpressure backflow was present. Normally, this would not occur because a boost pump in the supply line would keep the supply pressure to the storage tank always greater than the highest tank pressure. The addition of rust inhibiting chemicals to this tank greatly increased the degree of hazard of the liquid. Unfortunately, at the same time that the fire took place, the pressure in the water mains was reduced to a dangerously low pressure and the low pressure cutoff switches simultaneously shut off the storage tank booster pumps. This combination allowed the boiler water, together with its chemical contaminants, the opportunity to enter the potable water supply within the building. When normal pressure was reestablished in the water mains, the booster pumps kicked in, and the contaminated water was delivered throughout the building.

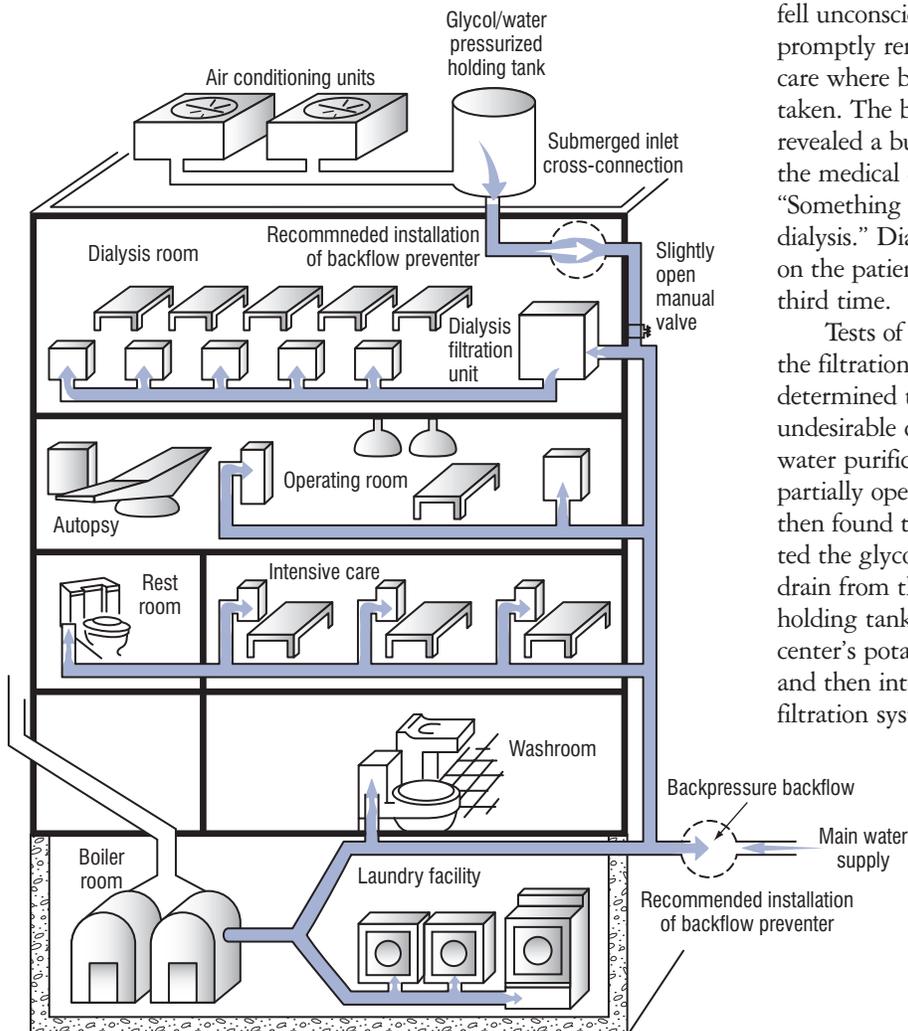
The glycol was added to the air conditioning water, and the glycol/water mix was stored in a holding tank that was an integral part of the medical center's air conditioning cooling system. Pressurized make-up water to the holding tank was supplied by a medical center

potable supply line and fed through a manually operated control valve. With this valve open, or partially open, potable make-up water flowed slowly into the glycol/water mixture in the holding tank until it filled to the point where the pressure in the closed tank equaled the pressure in the potable water supply feed line. As long as the potable feed line pressure was at least equal to, or greater than, the holding tank pressure, no backflow could occur. The stage was set for disaster, however.

faucet, which in turn dropped the pressure in the potable supply line to the air conditioning holding tank. Since the manually operated fill valve was partially open, this allowed the glycol/water mixture to enter the medical center potable pipelines and flow into the dialysis equipment. The dialysis filtration system takes out trace chemicals such as those used in the city water treatment plant, but the system could not handle the heavy load of chemicals that it was suddenly subjected to.

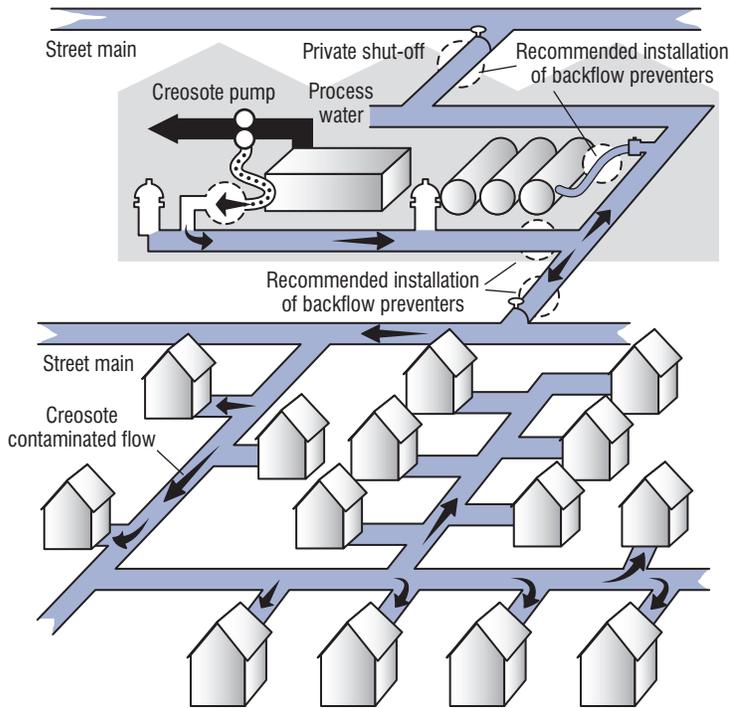
Detailed investigation of the cause of the incident disclosed that the wood preservative company, as part of their operation, pumped creosote from collective pits to other parts of their operation. The creosote pump would automatically shut off when the creosote in the pit was lowered to a predetermined level. After the creosote returned to a higher level, the pump would restart. This pump would lose its prime quite often prior to the pit refilling, and to prevent the loss of prime, the wood preservative company would connect a hose from a $\frac{3}{4}$ -inch hose bibb, located on the fire service line, to the suction side of the pump. The hose bibb remained open at all times in an effort to continuously keep the pump primed.

Repairs were necessary to one of the private fire hydrants on the wood preservative company property, necessitating the shutting down of one of two service lines and removal of the damaged fire hydrant for repair. Since the hydrant was at a significantly lower level than the creosote pit, the creosote back-siphoned through a $\frac{3}{4}$ -inch pump priming hose connecting the creosote pit to the fire service line.

After the repairs were made to the hydrant, and the water service restored, the creosote, now in the fire lines, was forced into the main water distribution system.

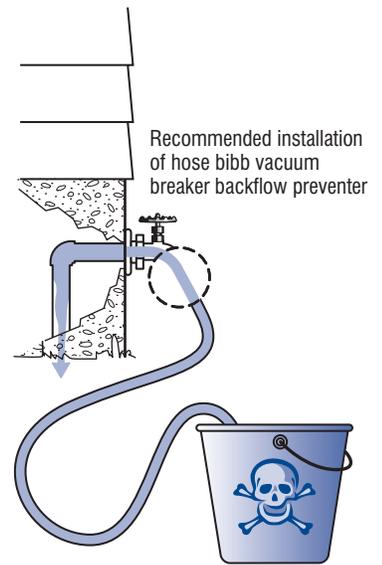
In August, 1978, a professional exterminator was treating a church located in a small town in South Carolina, for termite and pest control. The highly toxic insecticide chlordane was being mixed with water in small buckets, and garden hoses were left submerged in the buckets while the mixing was being accomplished. At the same time, water department personnel came by to disconnect the parsonage's water line from the church to install a separate water meter for the parsonage. In the process, the water was shut off in the area of the church building. Since the church was located on a steep hill, and as the remaining water in the lines was used by residents in the area, the church was among the first places to experience a negative pressure.

The chlordane was quickly siphoned into the water lines within the church and became mixed with the Kool-Aid being prepared by women for the vacation bible school. Approximately a dozen children and three adults experienced dizziness and nausea. Fortunately, none required hospitalization or medical attention.
